CERL Technical Report 99/37  
May 1999

# **Robotic Underwater Corrosion Inspection/Assessment of Sheet Pile Along Two Rivers at Cleveland, Ohio**

## **Cuyahoga River Bulkhead Study: Phase 2 Report**

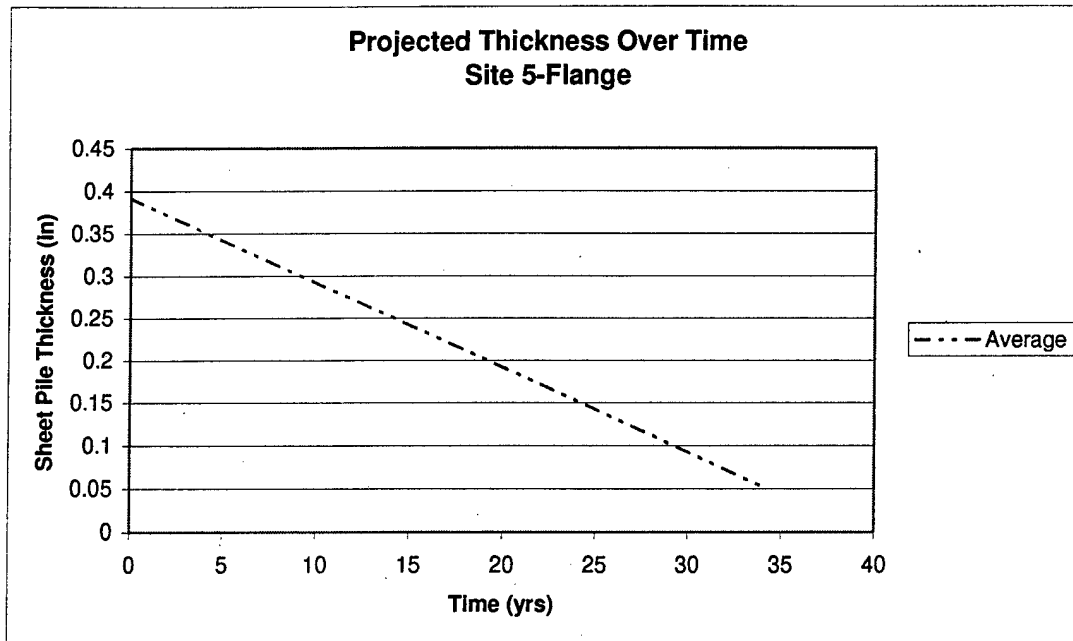
Figure 15. Site 5 flange thickness projected over time. Note: There were too few reliable measurements to determine a valid max/min range in this case.

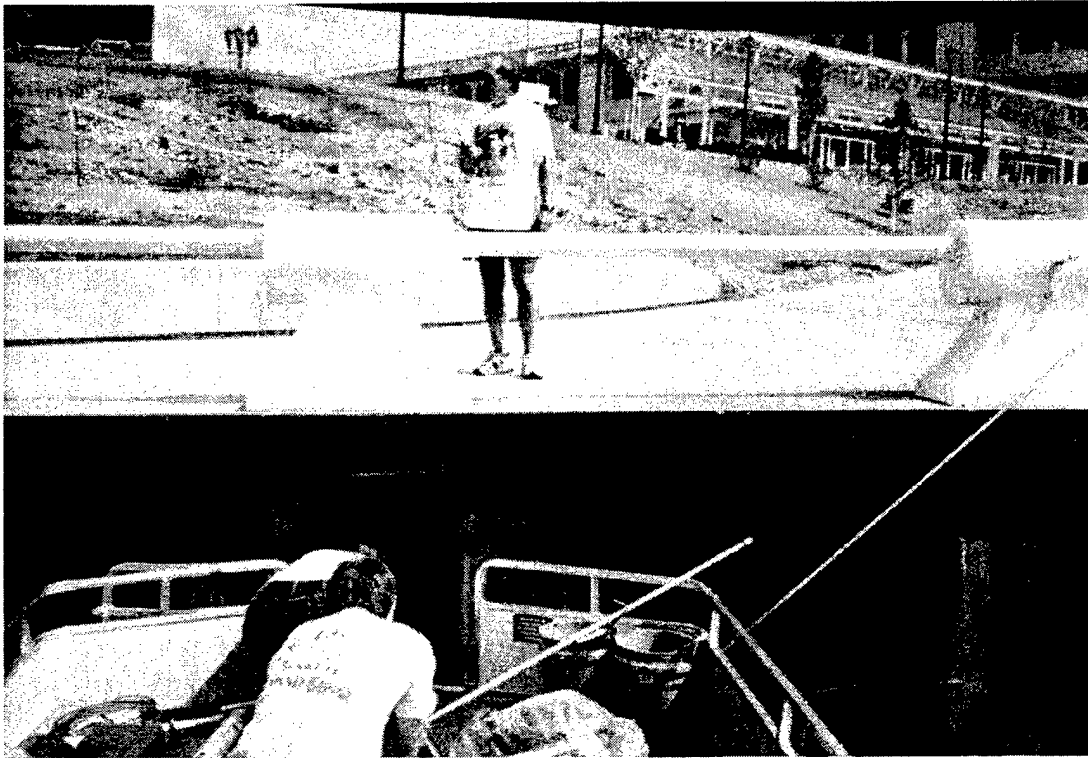
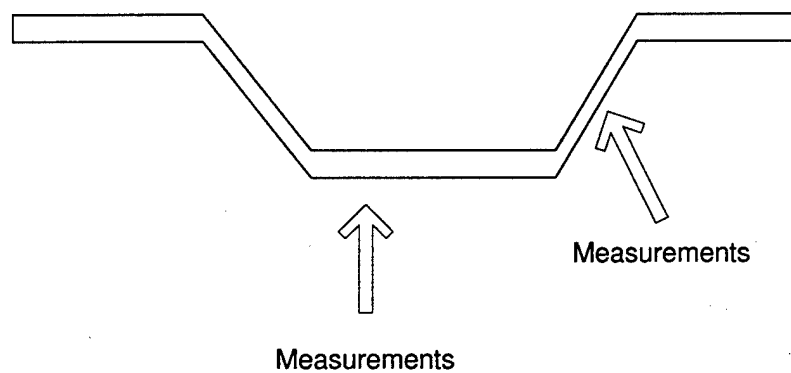
## Site 1

Site 1 Location: Parks1/Parks 3, City of Cleveland Parks and Recreation, next to Frank Morrison and Son; just north of marker 540 on east shore.

Type of sheet pile: cold-rolled.

Measurements: Taken on the northeastern side approximately 40 ft upriver from water fountain. Measurements were taken on the flange and the web of the sheet pile.

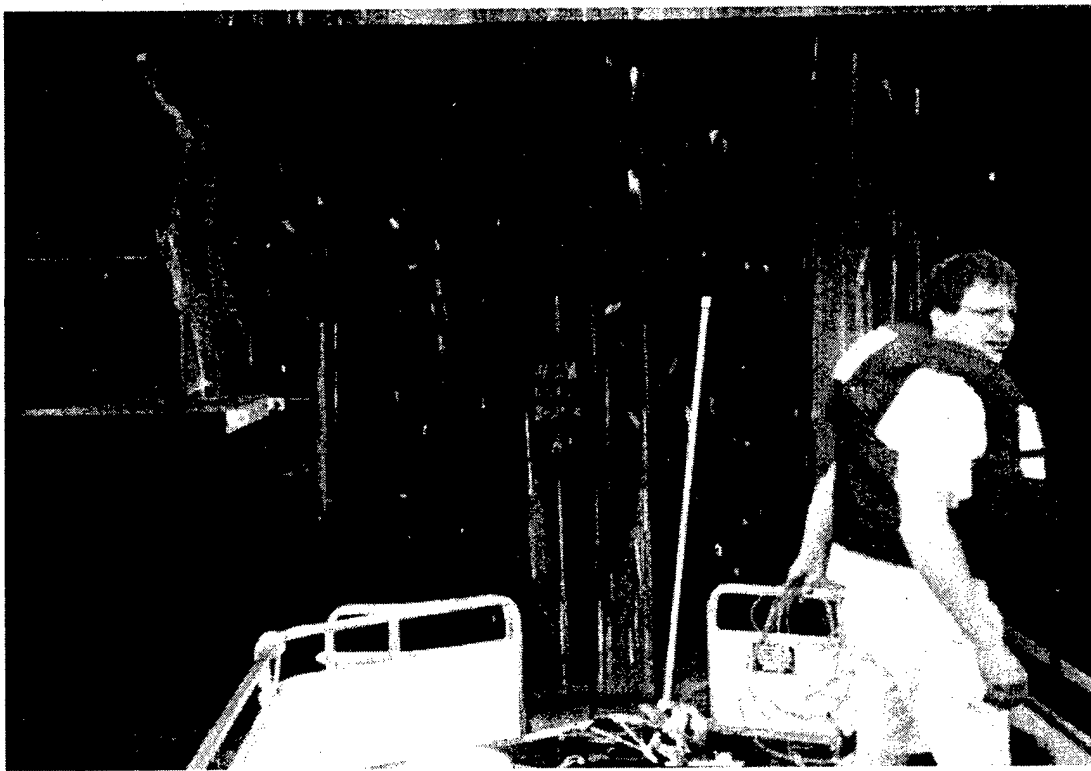
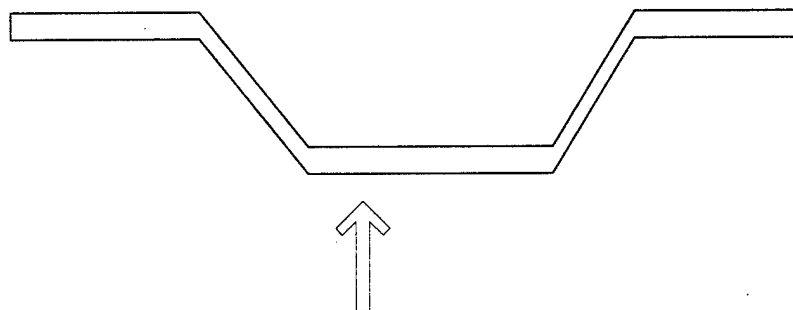
## Site 2

Site 2 Location: Glazer 4/City of Cleveland 32 or City of Cleveland 31, approximately 400 ft south of Site 1 between markers 540 and 548 on east shore.

Type of sheet pile: cold-rolled.

Measurements: Taken from the first full sheet pile section down from the platform on the bulkhead. All measurements were taken on the flange of the sheet pile.

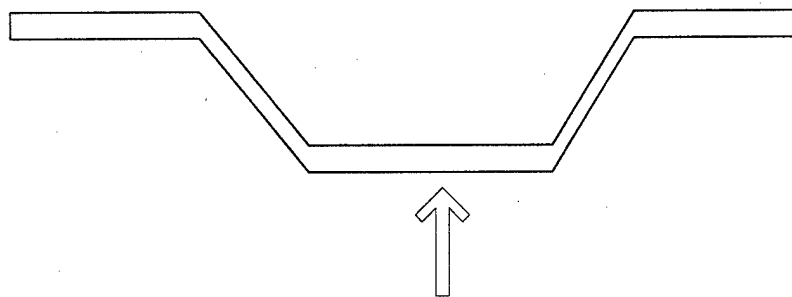
**Site 3**

Site 3 Location: Cereal 1 / Cereal 2 or Cereal Food Processors 3, just north of marker 559 on the east shore.

Type of sheet pile: hot-rolled in front.

Measurements: Taken below the yellow triangle next to the 624A marker on the sheet pile, near the northwest corner of the grain loading tower. All measurements were taken on the flange of the hot-rolled sheet pile.

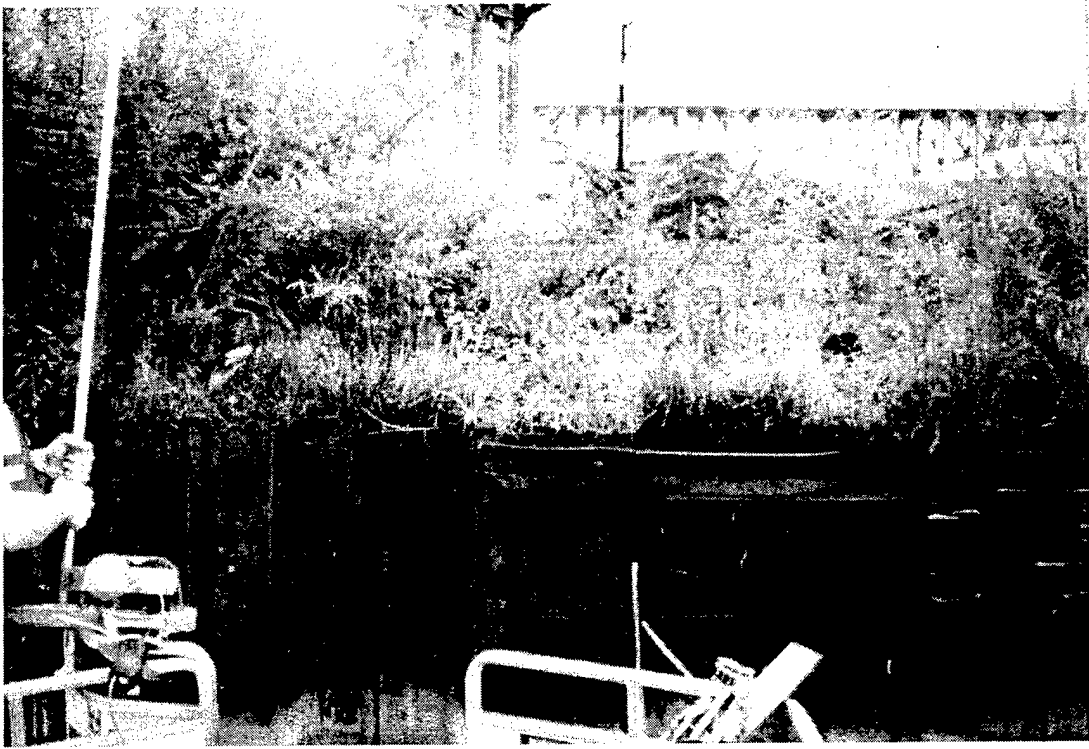
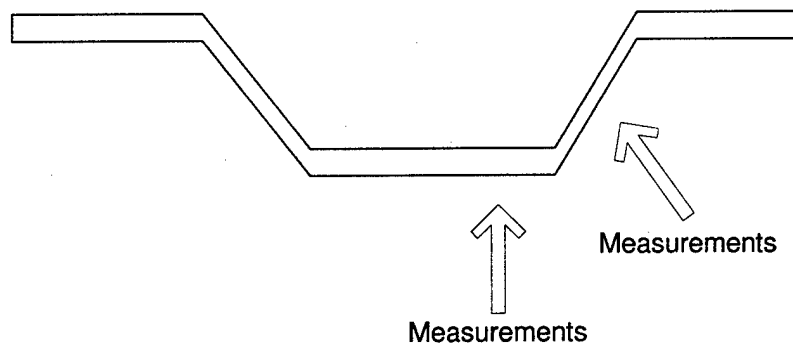
**Site 4**

Site 4 Location: Mid-Continental Coal/Coke 2, halfway between markers 640 and 650 on the east shore.

Type of sheet pile: hot-rolled.

Measurements: Measurements taken close to the 650 sheet pile marker. Measurements were taken on the flange of the sheet pile by Fury and Panametrics. Panametrics measurements were also taken on the web.

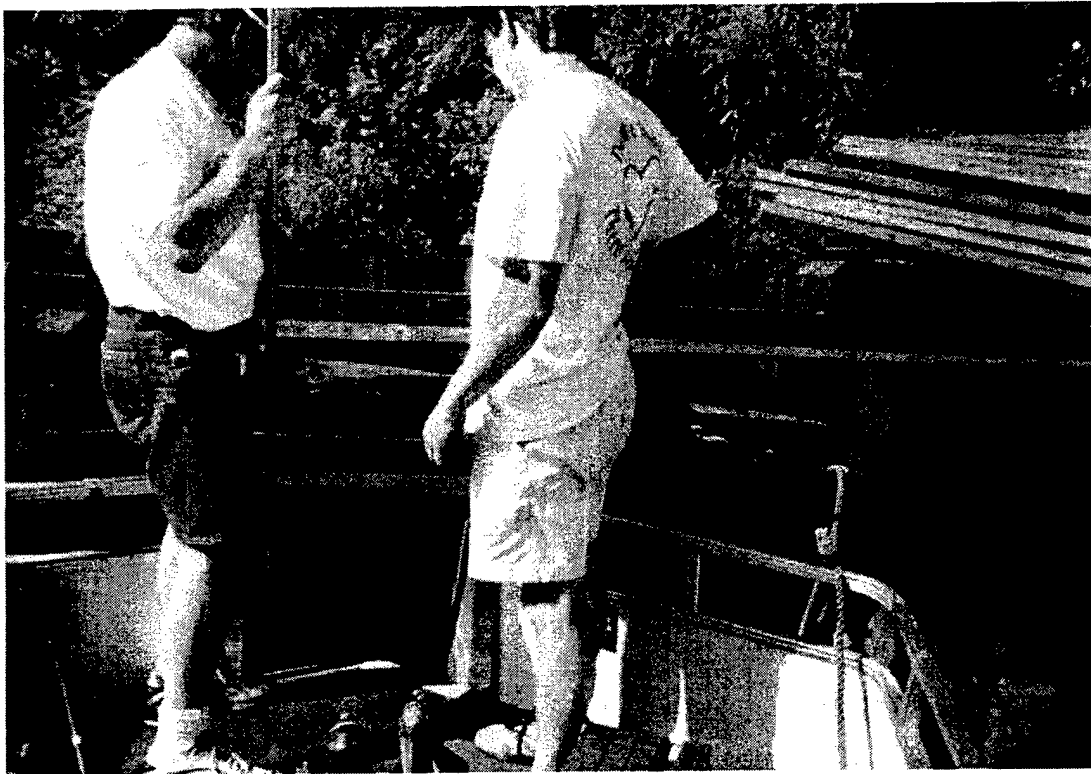
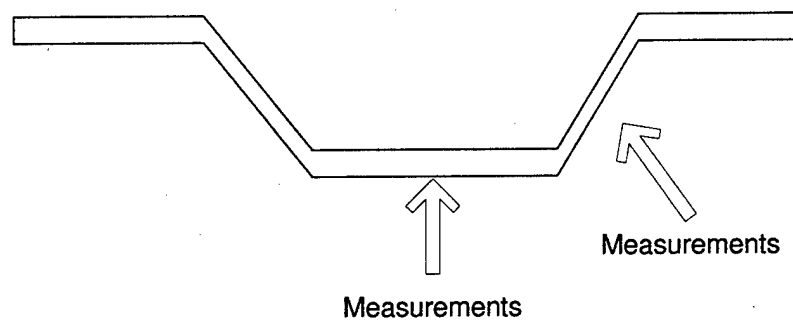
## Site 5

Site 5 Location: Erie RR 10/Sta Realty 2, on outcropping between markers 660 and 670, closer to 670 on west shore.

Type of sheet pile: hot-rolled.

Measurements: Two measurements were taken on the web by Panametrics. All other measurements were taken on the flange by Fury and Panametrics.

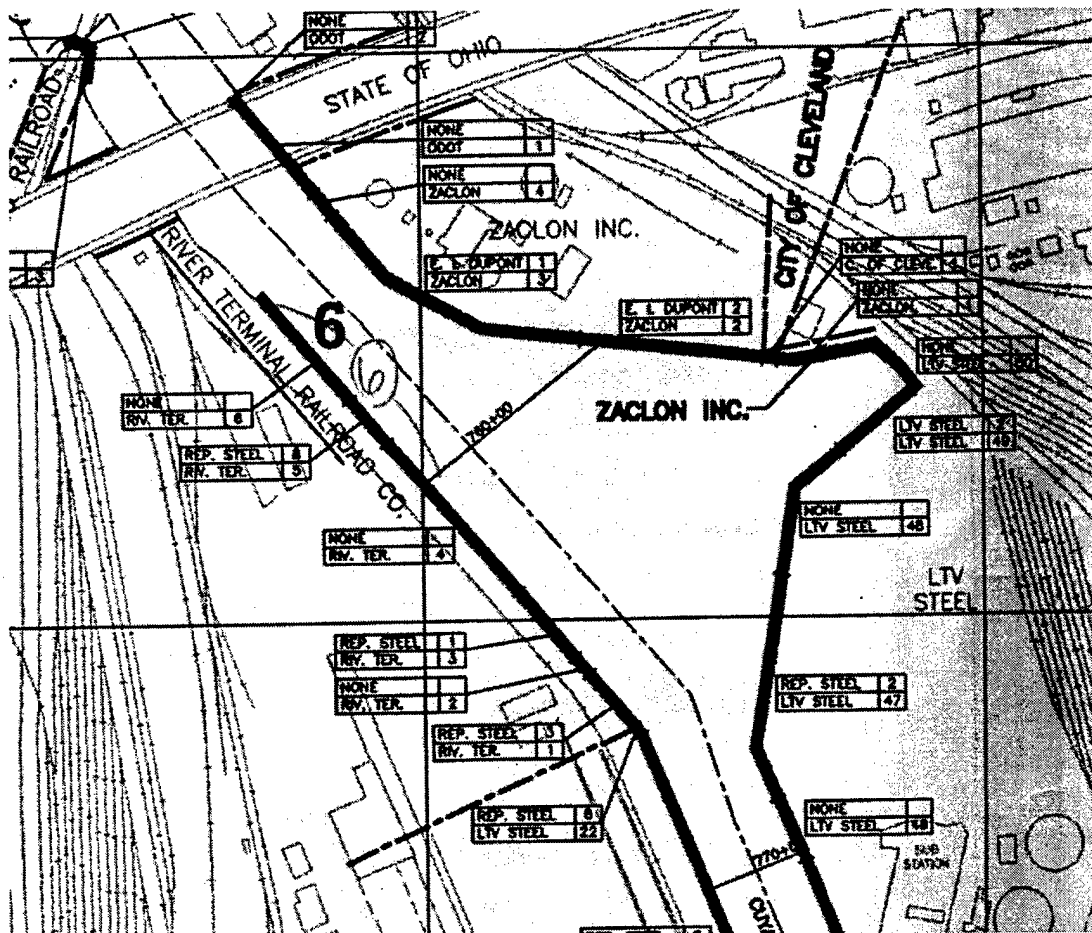
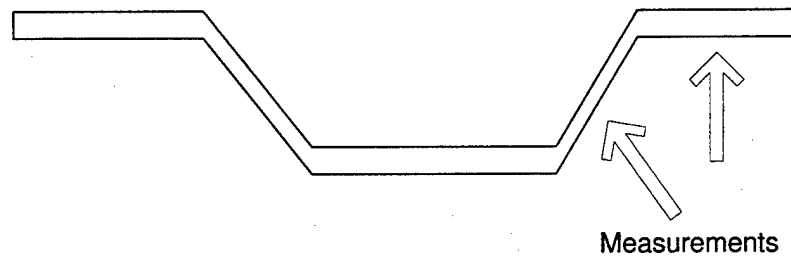
## Site 6

**Site 6 Location:** River Terminal 6, just north of marker 760 on southwest shore.

Type of sheet pile: hot-rolled.

**Measurements:** Measurements were taken on the back flange of the sheet pile by Fury. Panametrics measurements were taken on the web.

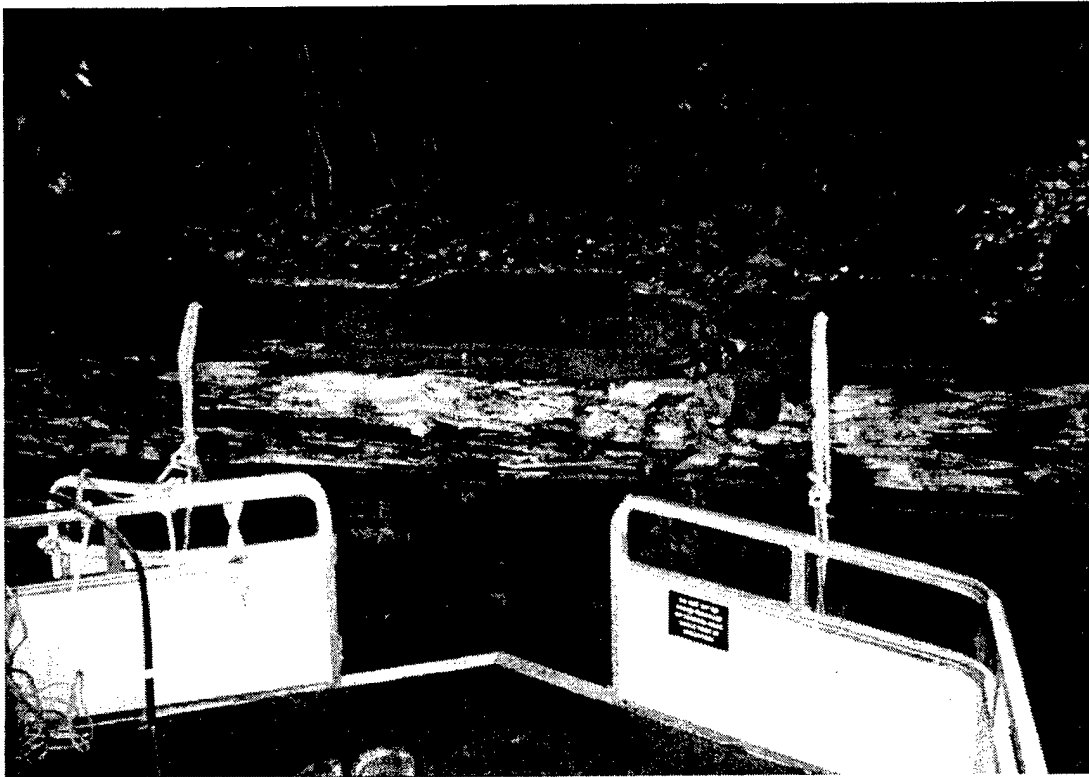
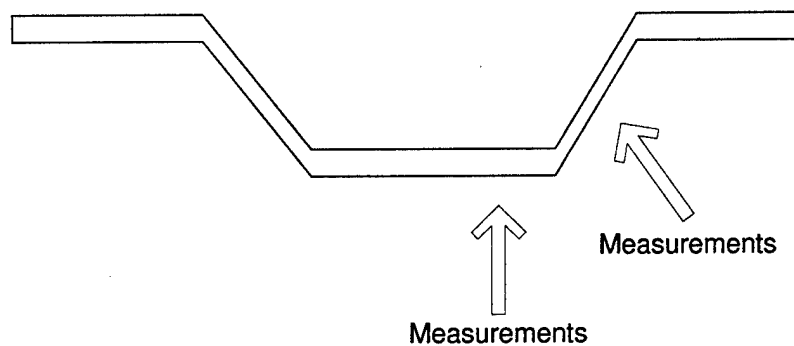
## Site 7

Site 7 Location: Carter 1, between Samsel Realty and Carter Peninsula; just south of marker 610 on the east shore.

Type of sheet pile: hot-rolled.

Measurements: Taken near station 610+00. Two measurements were taken on the flange of the sheet pile by Panametrics. All other measurements were taken by Fury and Panametrics on the web.

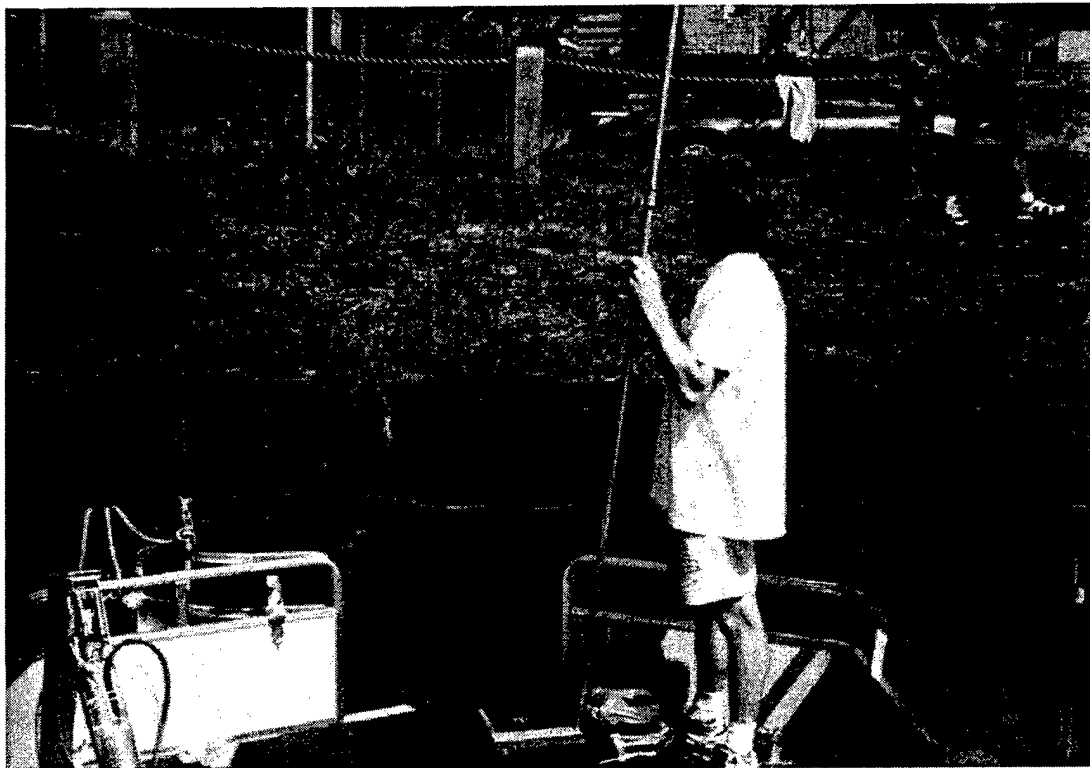
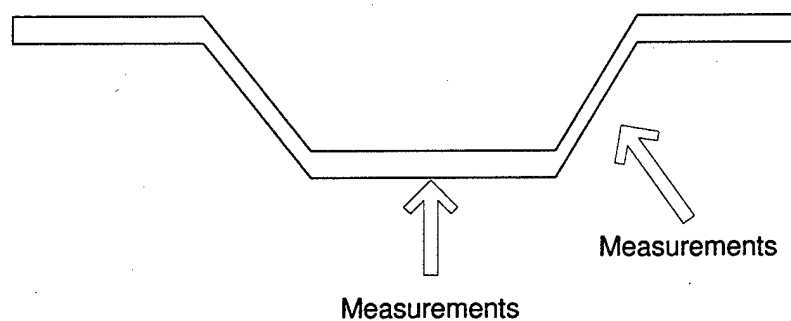
## Site 8

Site 8 Location: B&O RR 1/ Tower City 1, between Tower City and F.C. Southridge Corp.; between markers 620 and 630 on the north shore.

Type of sheet pile: hot-rolled.

Measurements: Measurements were taken on the flange of the sheet pile by Fury and Panametrics. Panametrics measurements were also taken on the web.

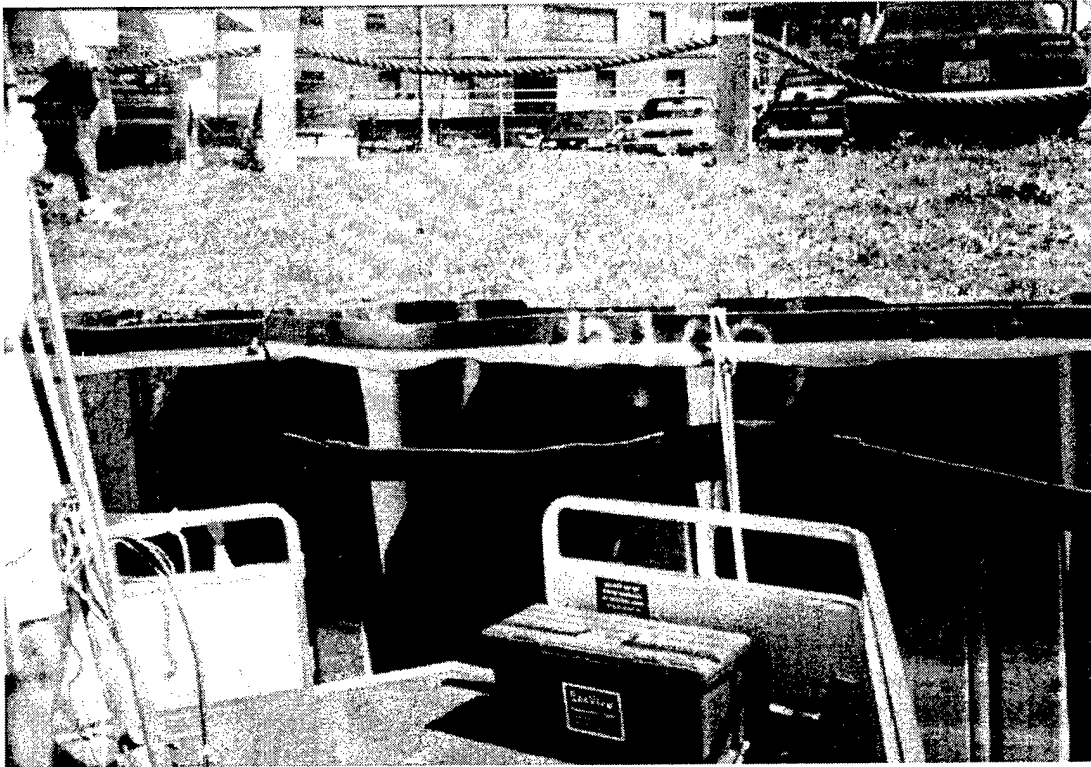
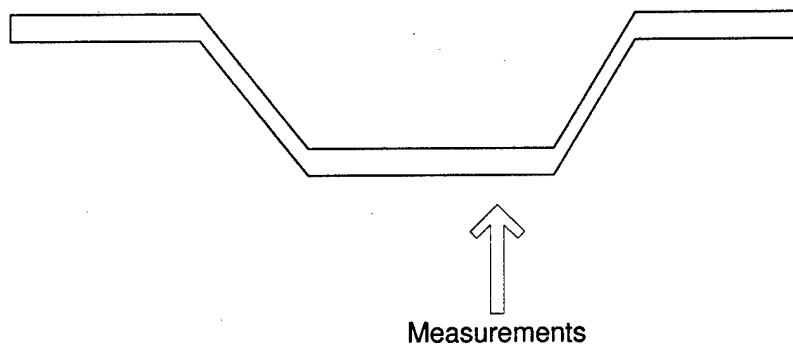
**Site 9**

Site 9 Location: B&O RR 1/Mid-Continental 5, between markers 630 and 640, on east shore.

Type of sheet pile: hot-rolled.

Measurements: All measurements were taken on the flange by Panametrics.

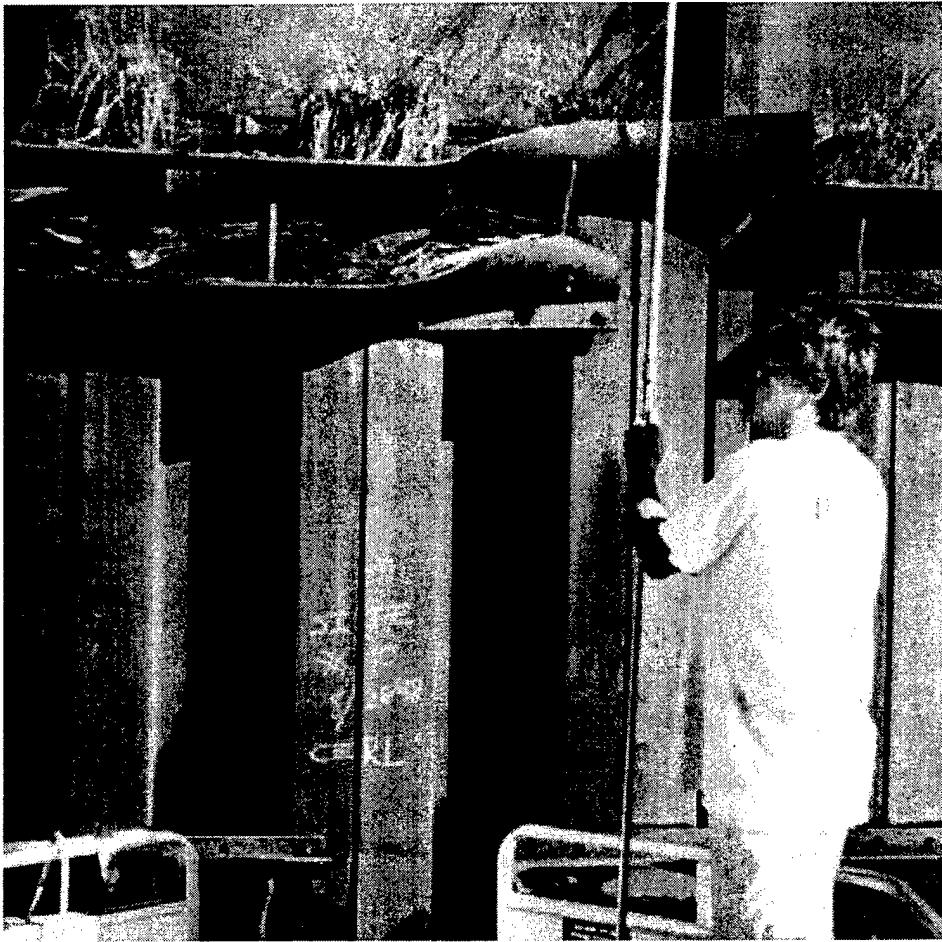
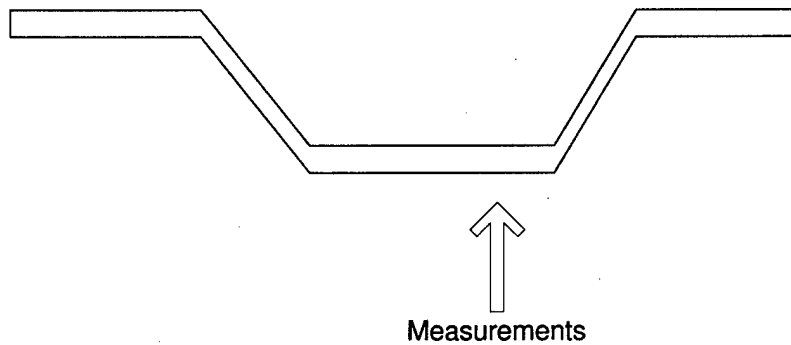
**Site 10**

Site 10 Location: Republic Steel 7/ LTV Steel 31, between 800 and 810 on the east shore.

Type of sheet pile: hot-rolled.

Measurements: Close to station 800+50, at front of Sun Oil terminal. All measurements were taken on the flange of the sheet pile by Fury and Panametrics.

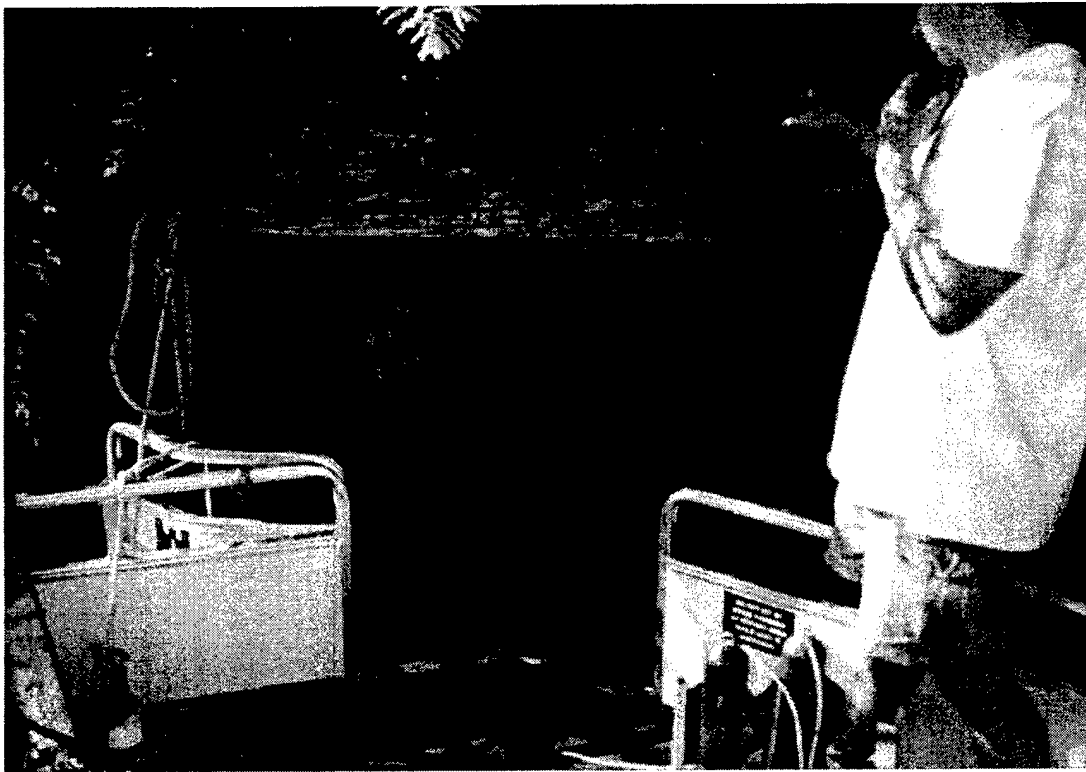
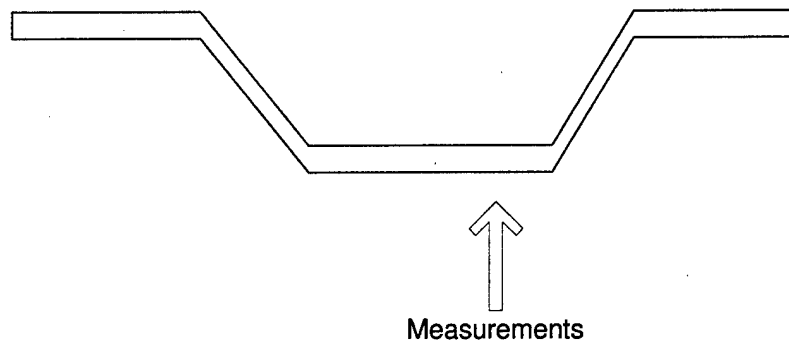
## Site 11

Site 11 Location: B&O Railroad 7 / B&O Railroad 5, slightly east of marker 700 on the north shore.

Type of sheet pile: hot-rolled.

Measurements: All measurements were taken on the flange of the sheet pile by Fury and Panametrics.

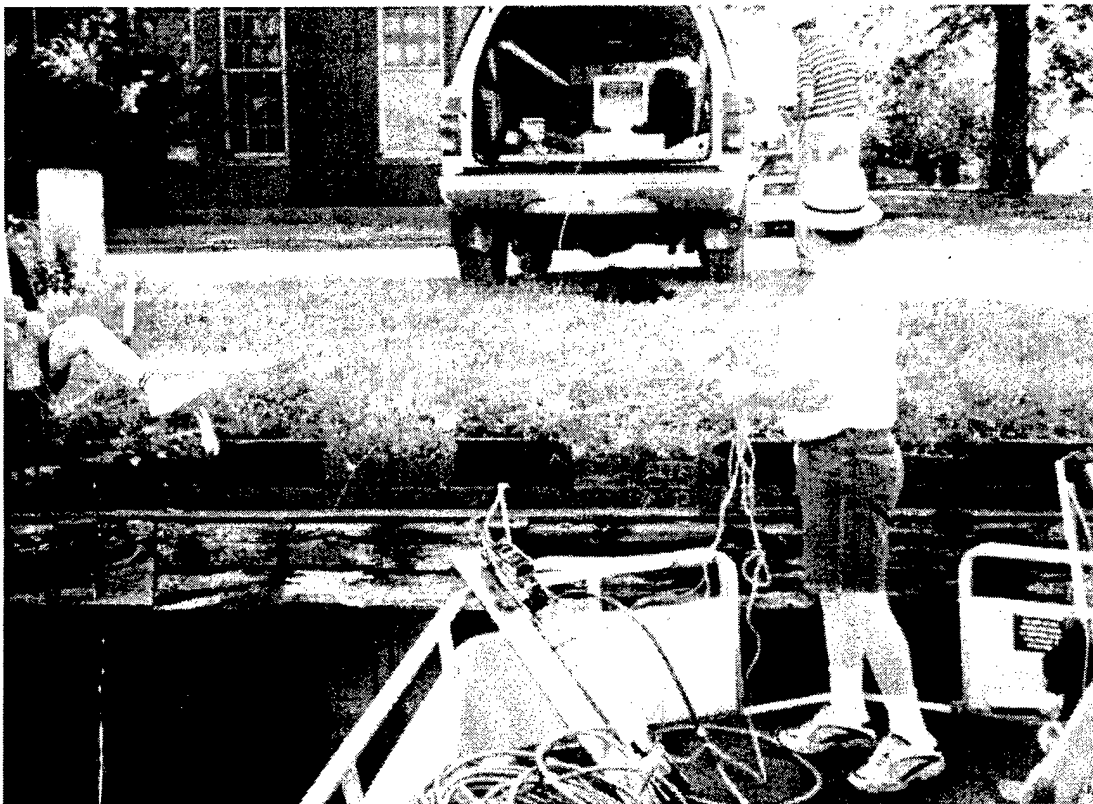
## Site 12

Site 12 Location: Erie RR 6 / Ontario Stone 4, between markers 320 and 310 on the south shore.

Type of sheet pile: hot-rolled.

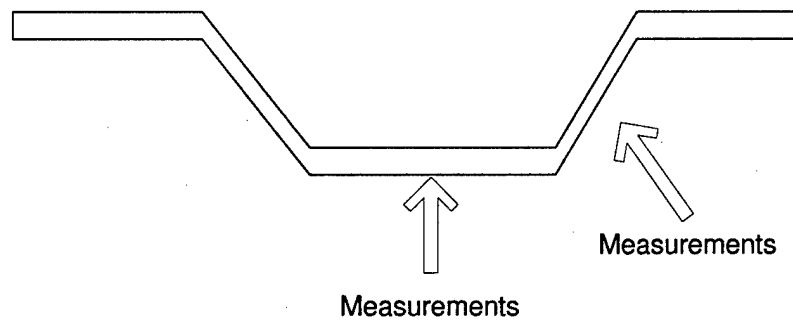
Measurements: Site near the end of the building. Measurements were taken on the web by Fury and Panametrics. One Panametrics measurement was taken on the flange.

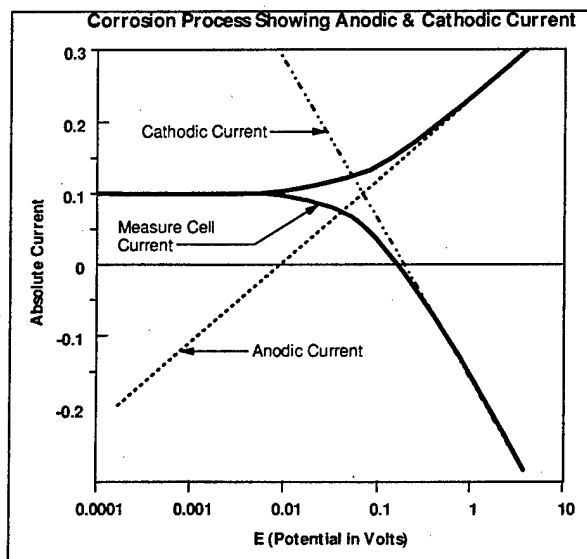
Figure 35: Corrosion process showing anodic and cathodic current. It should be noted that the current from each half reaction depends on the electrochemical potential of the metal.

Figure 35 diagrams this process. The vertical axis is potential and the horizontal axis is the logarithm of absolute current. The theoretical currents for the anodic and cathodic reactions are shown as straight lines. The curved line is the sum of the anodic and cathodic currents. It is the current that is measured when a sweeping scan of the potential of the metal is made. The sharp point in the curve results from the use of a logarithmic axis. It is actually the point where the current gets very small prior to changing sign.

The potential of the metal is the means by which the anodic and cathodic reactions are kept in balance (Figure 35).

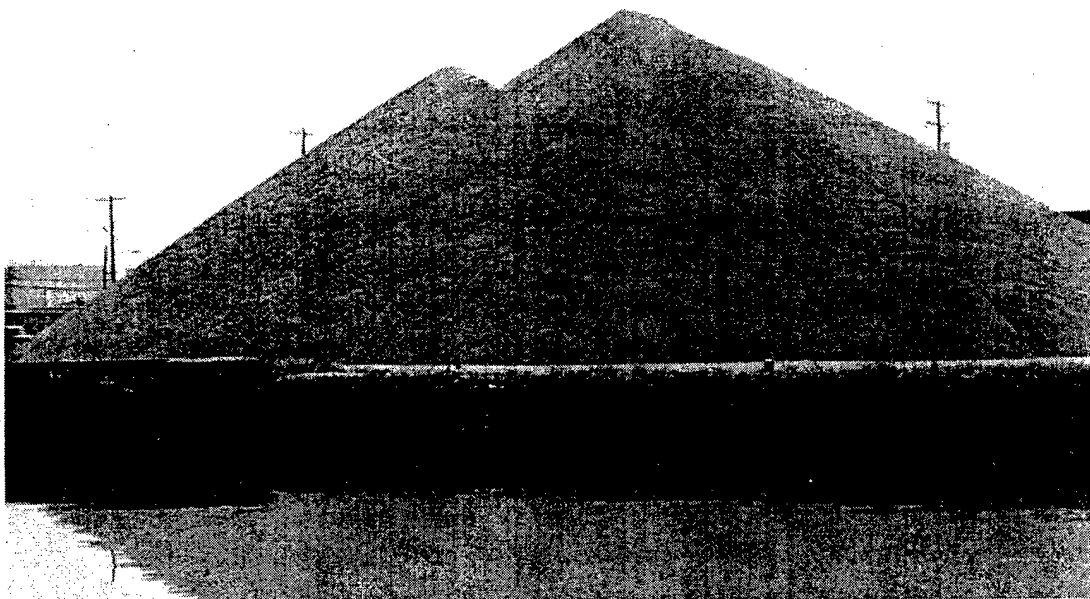
Figure 36. Coal storage at Site 4, the Mid-Continental Coke and Coal property.

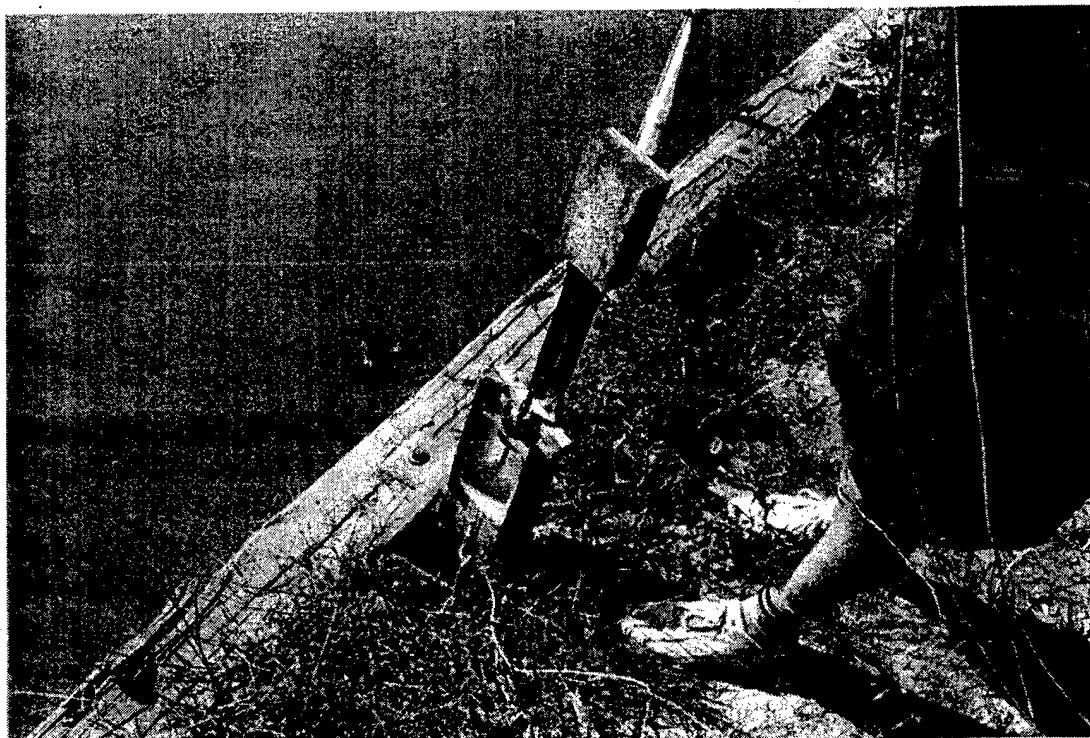
Figure 37. Polarization resistance testing device.

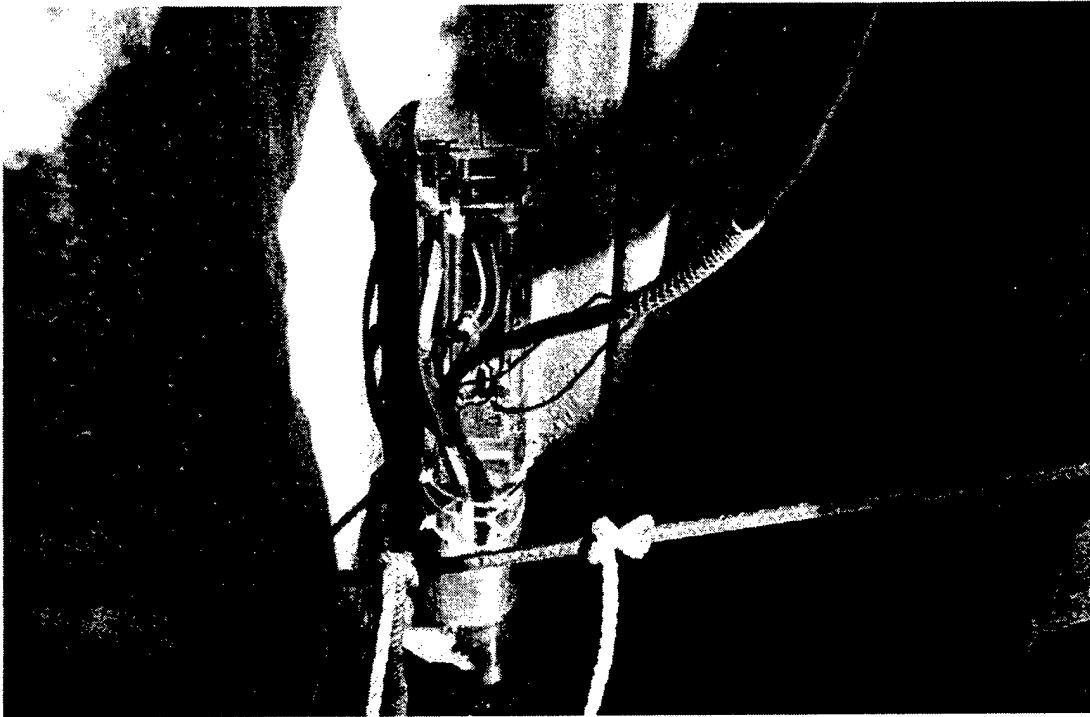
Figure 38. Fury robot entering the water on the back flange of the sheet pile.

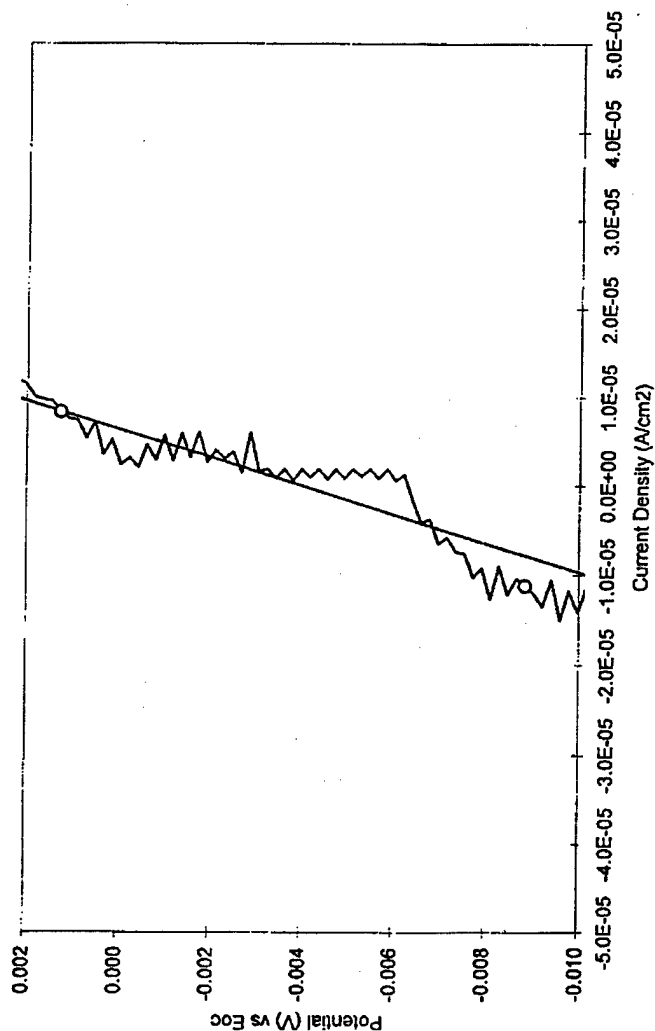
Polarization Resistance  
'coepr#4a.dta' 8/25/1998-12:37:18

Rp = 6.241E+02 Ohm cm<sup>2</sup>

CorrRate = 51.982 mpy
